PINE STREET POLICE STATION

EXTERIOR REHABILITATION

Location: Baltimore, Maryland
Client: University of Maryland, Founding Campus
Category: Institutional

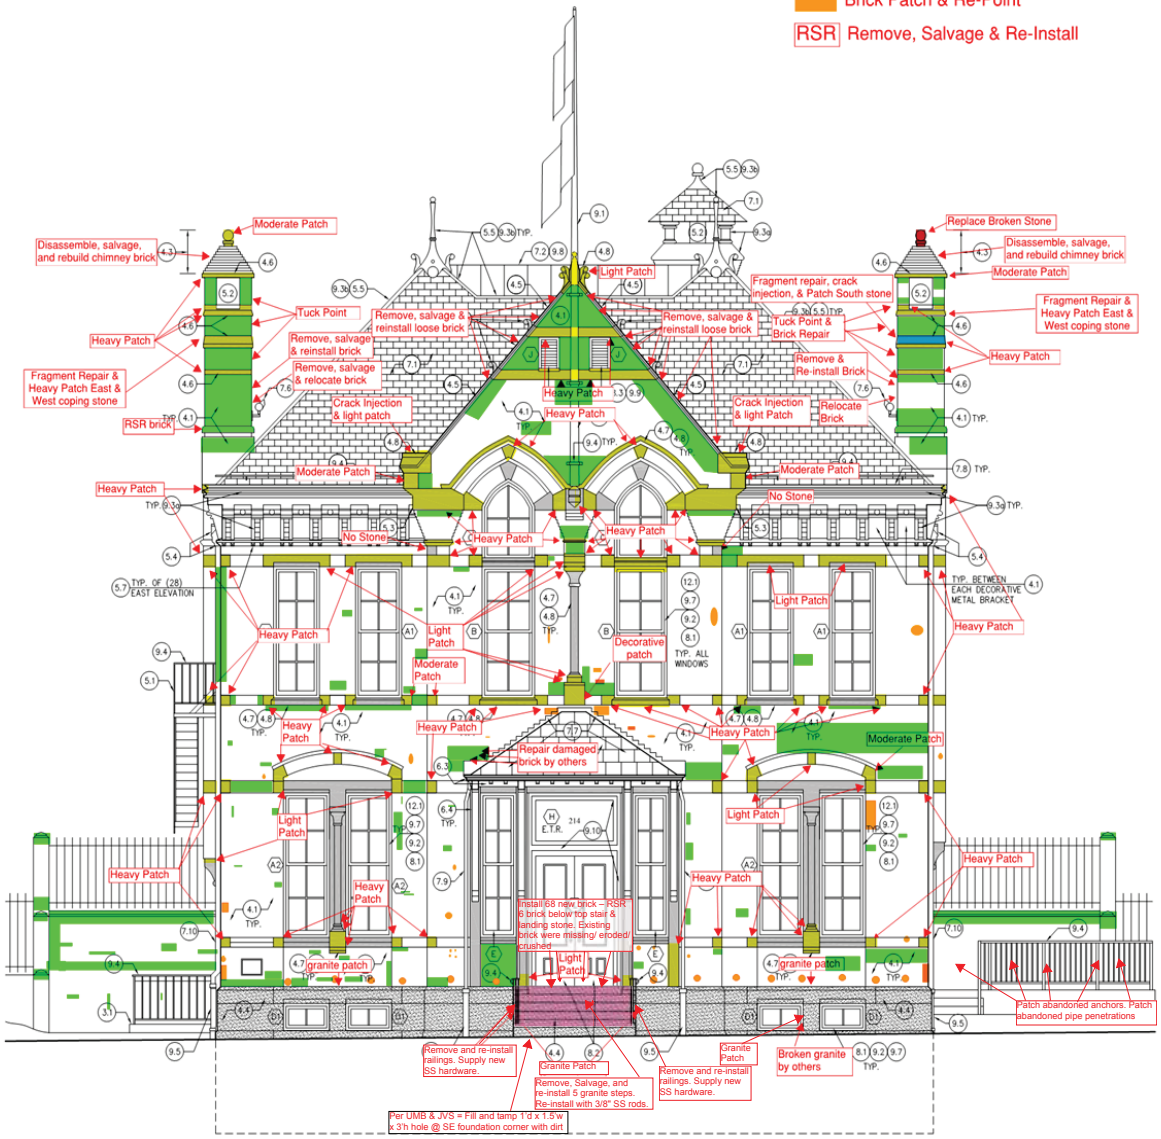
01 EAST ELEVATION
1/4" = 1'-0"

- Tuck Point Brick Masonry
- Patch Sandstone
- Replace Stone
- Brick Patch & Re-Point
- RSR Remove, Salvage & Re-Install

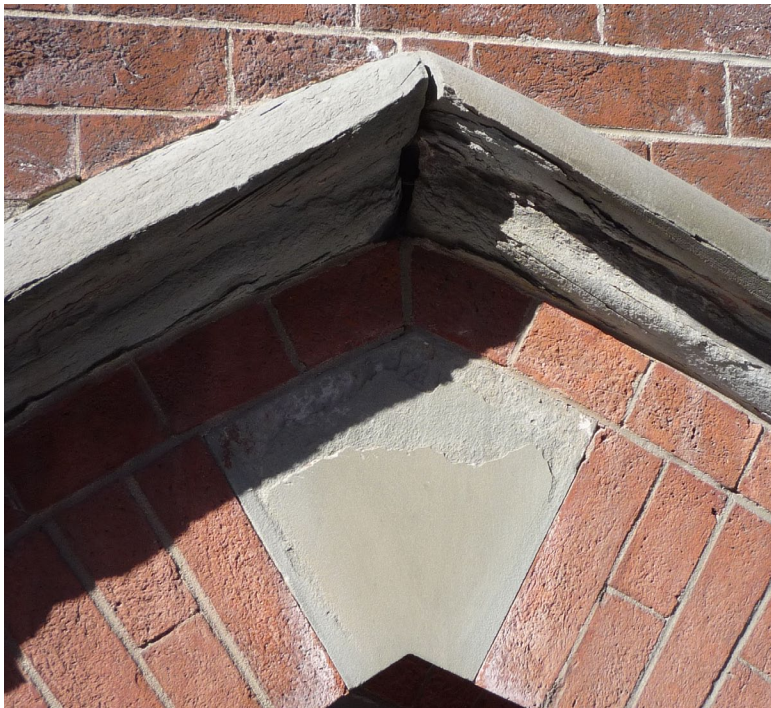
MASONRY WORK BEFORE

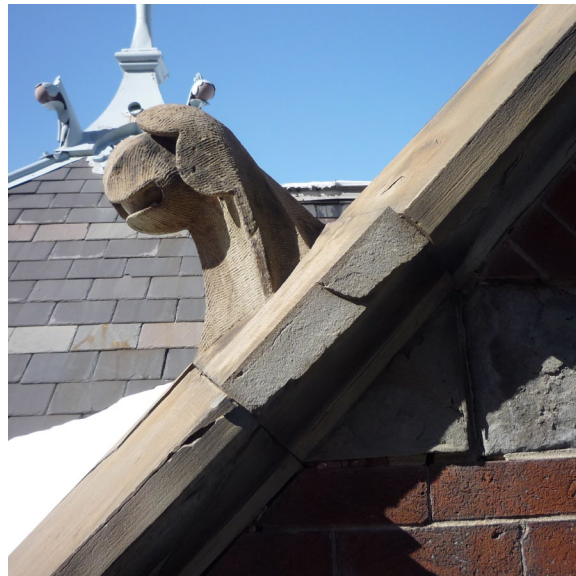
MASONRY WORK BEFORE

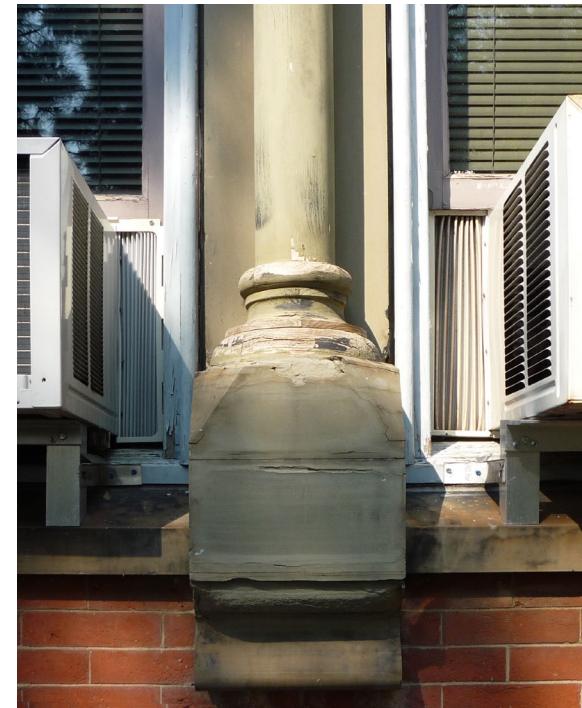
MASONRY/WINDOW WORK BEFORE

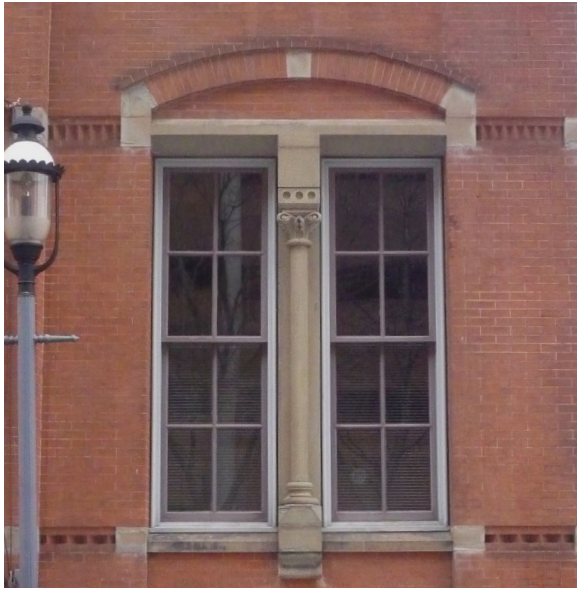
WINDOW/MASONRY WORK BEFORE

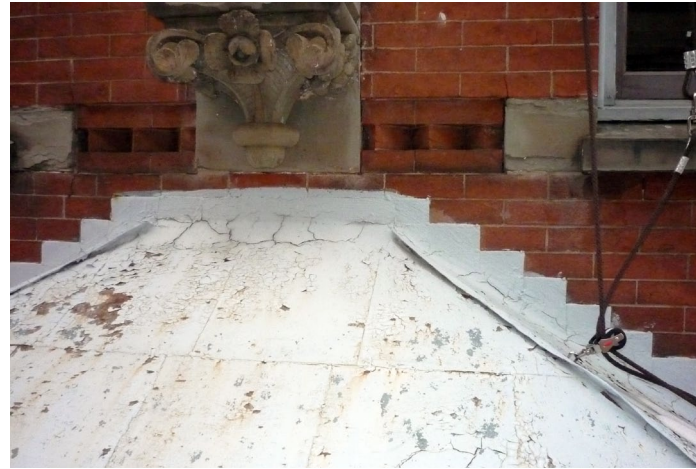
ROOFING/MASONRY WORK BEFORE

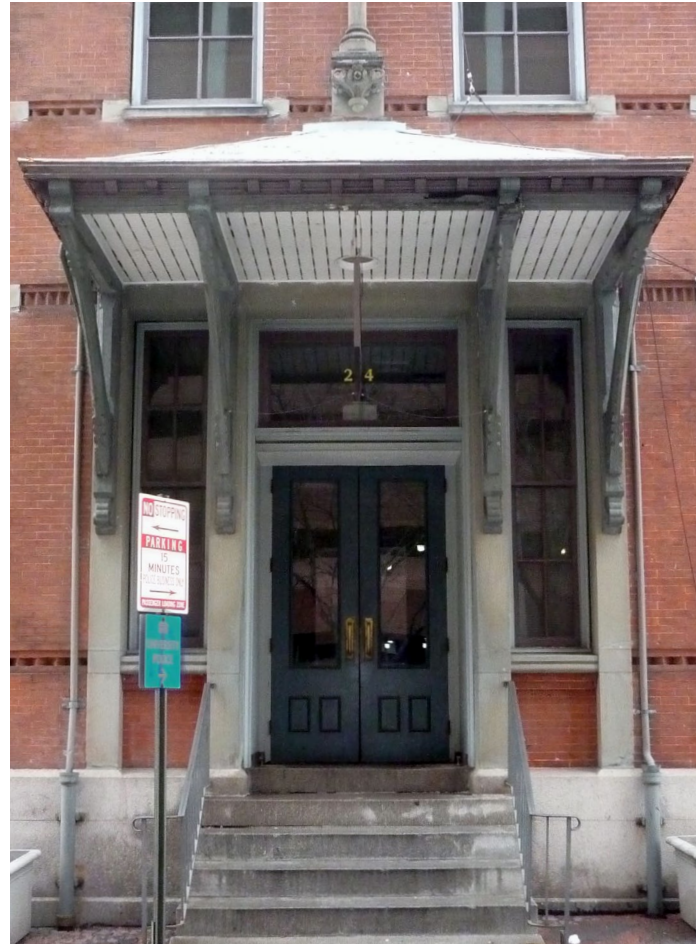
ENTRANCE WORK BEFORE
