Institutional Architecture

Sandy Spring MD

This project rehabilitates a historic (1832) three-story stone bank barn, adjacent carriage house (1897), and site for public use as a visitor center and museum at the core of the Woodlawn Manor Cultural Park. The site is on the county's Master Plan for Historic Preservation, the Maryland Historic Trust interior and exterior easement program, the National Park Services' National Underground Railroad Network to Freedom, and is eligible for listing on the National Register of Historic Places.

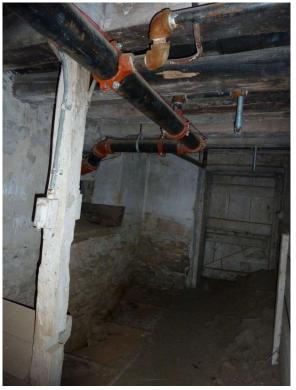
The lower level of the barn contained charred timbers, lead paint, improper mortar repairs, an intrusive and leaky sprinkler system, and an uneven dirt floor.

The lead paint has been encapsulated, surfaces whitewashed, timbers replaced, floors stabilized, lighting added, and audio and visual exhibits installed.

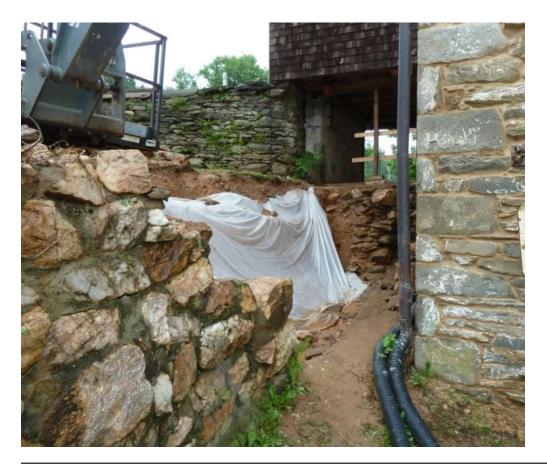
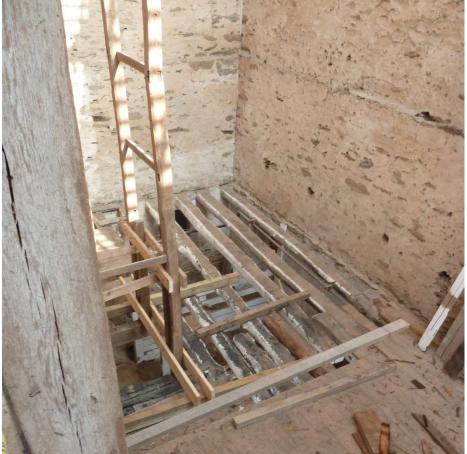
Fire-damaged flooring in the middle level was replaced. The stone walls were repaired and cleaned, but care was taken not to lose layers of history by doing too much.

The outer of two retaining walls, which have allowed the Barn to stand since 1832 without significant bowing, needed extensive repairs.

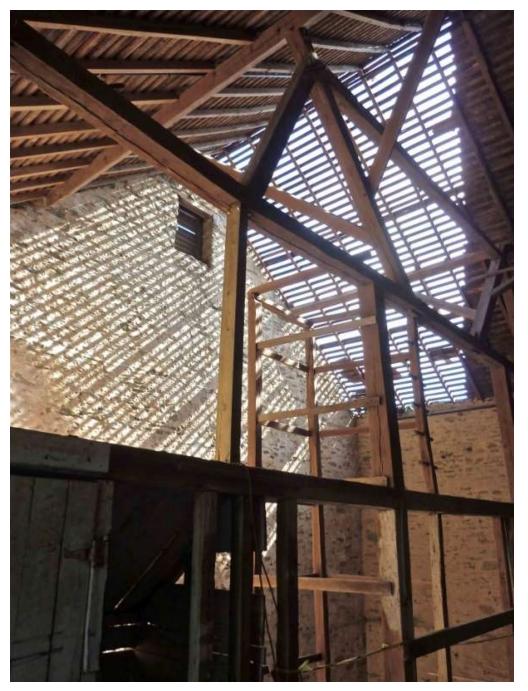
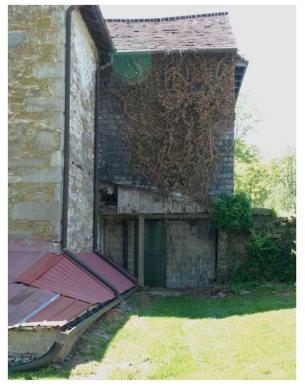
The upper level exterior required repairs and reshingling. The non-historic cinderblock was removed from the middle level entrance. Drainage issues around the barn and the side shed (red roof) were addressed.

With the old roof removed and before new cedar shingles are installed, the barn interior is illuminated.

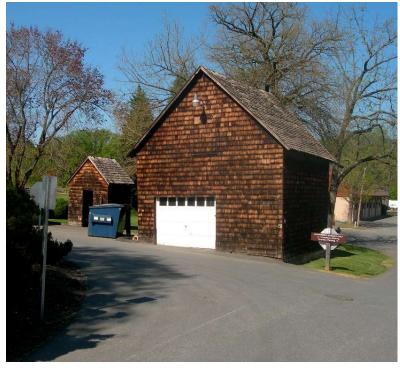
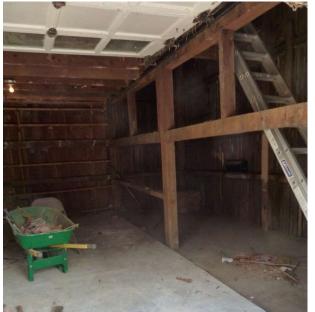
The existing Carriage House had a pest and water-damaged foundation and no windows. The interior was an enclosed garage, used for storage, with a steep narrow stair to a loft above the garage.

The equipment in the existing pump house to the north of the Carriage House (visible in plan, right, and behind the blue dumpster, above left) needed to be incorporated into the restroom addition.
