**Smithsonian Institution
National Postal Museum:
William H. Gross Stamp Gallery Expansion**
2 Massachusetts Ave NW, Washington DC
Cultural-Institutional Category

The Smithsonian's National Postal Museum, located on the lower level of the historic 1914 City Post Office Building, expanded to a new gallery to feature its multi-million dollar stamp collection and at the same time gain a much needed public presence at street level.

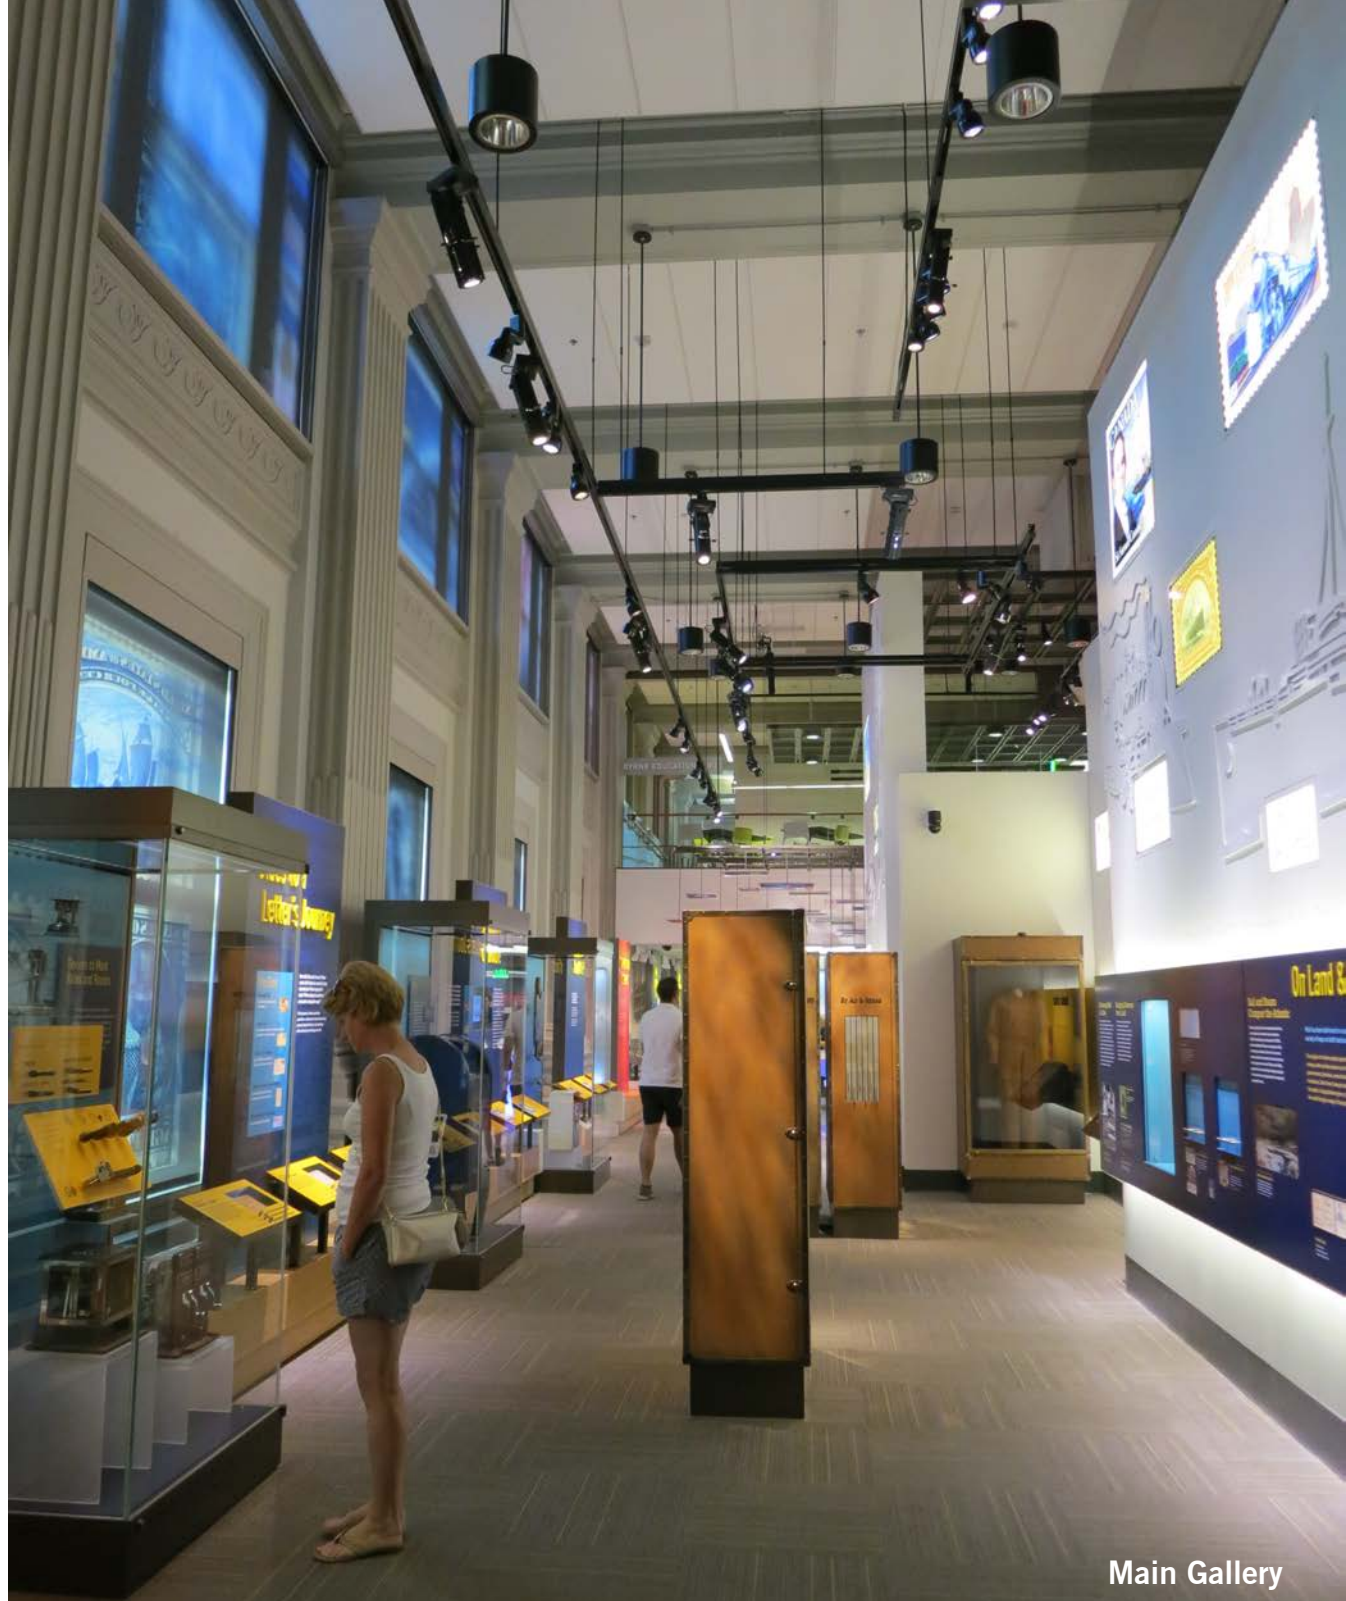
Main Gallery

Light Control

Exhibit walls were used to zone the museum for video displays and light-sensitive artifacts.
