The Seminary Ridge Museum, Gettysburg, Pennsylvania

The Seminary Ridge Museum is the result of the painstaking multi-year design and rehabilitation of Schmucker Hall - the 1832 National Register Historic Landmark located on the campus of the Lutheran Theological Seminary of Gettysburg – where the sighting of Confederate troops advancing on the small Pennsylvania town occurred from the building's cupola in 1863.

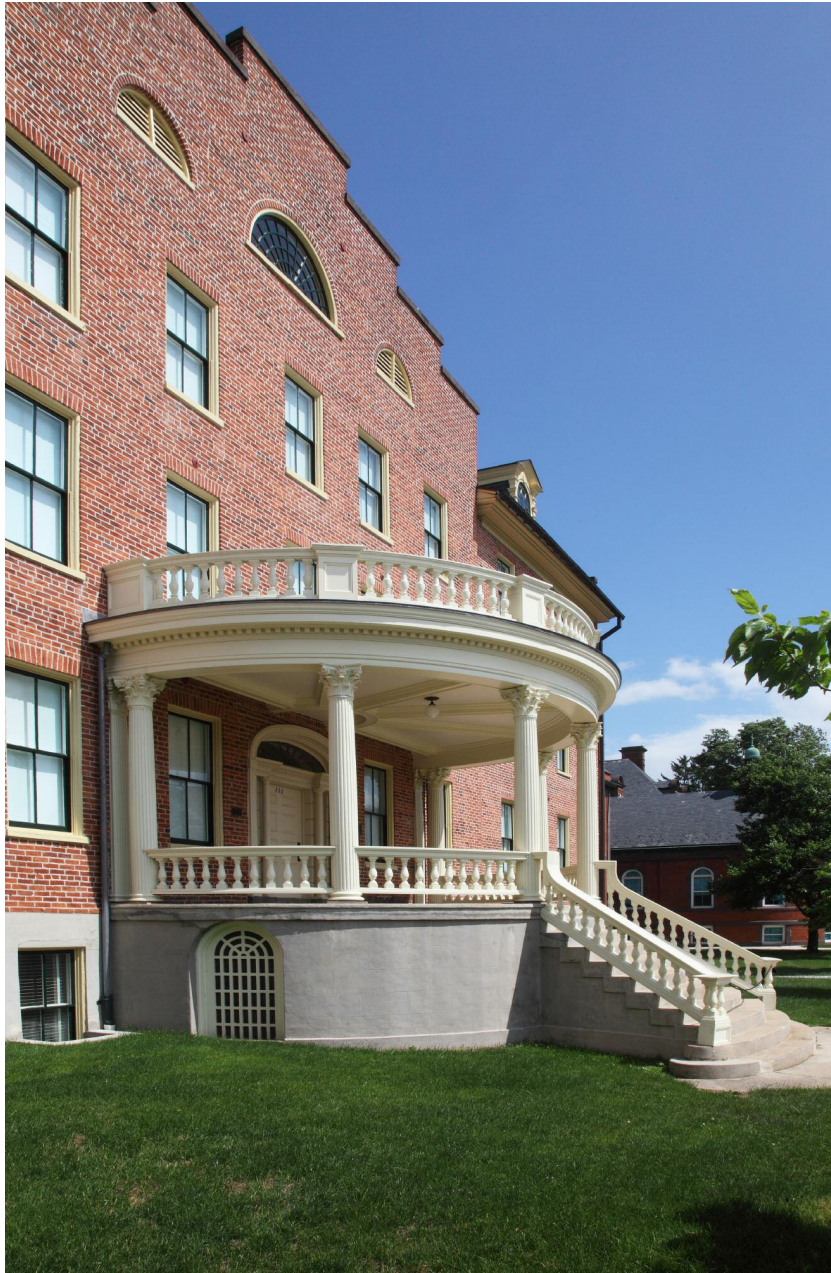
Reconstructed Peace Portico

The exterior preservation focused on repairs and restoration of the building facade components including windows, doors, dormers and cupola - along with a visual transformation back to the original historic paint colors from the existing pervasive white. Other exterior modifications included a new ADA-compliant entrance and terrace delicately inserted underneath the repaired/reconstructed historic east porch/entry stair, and the reconstruction of the "missing" Peace Portico, originally added to the west facade in 1914 to celebrate post-Civil War reconciliation.
