Institutional Architecture

Sandy Spring MD

This project rehabilitates a historic (1832) three-story stone bank barn, adjacent carriage house (1897), and site for public use as a visitor center and museum at the core of the Woodlawn Manor Cultural Park. The site is on the county's Master Plan for Historic Preservation, the Maryland Historic Trust interior and exterior easement program, the National Park Services' National Underground Railroad Network to Freedom, and is eligible for listing on the National Register of Historic Places.

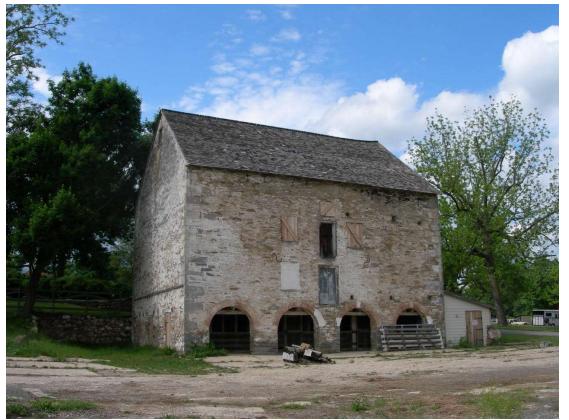
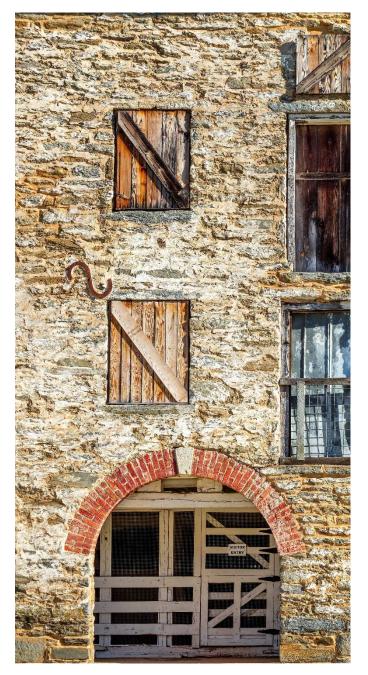
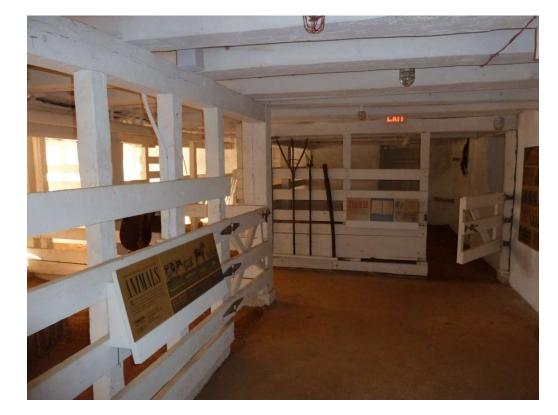
The lower level of the barn contained charred timbers, lead paint, improper mortar repairs, an intrusive and leaky sprinkler system, and an uneven dirt floor.

The lead paint has been encapsulated, surfaces whitewashed, timbers replaced, floors stabilized, lighting added, and audio and visual exhibits installed.

The exterior has been repointed with lime mortar, the brick arches cleaned, the shutters repaired or replaced, and hogwire railings added at full-height openings.

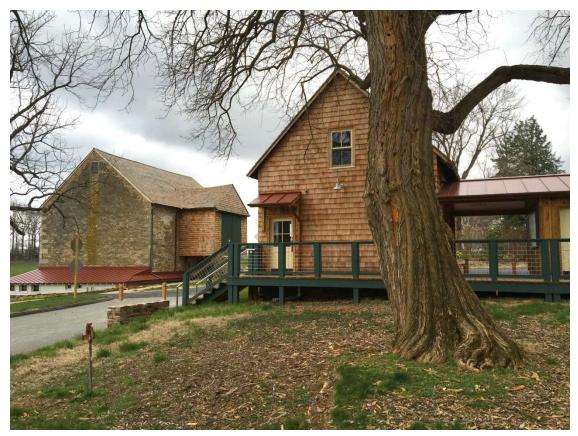
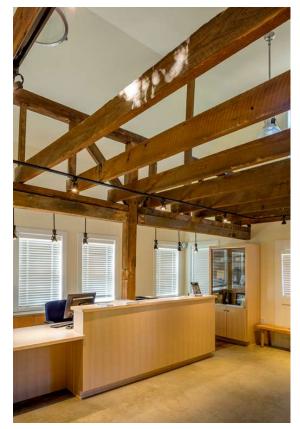
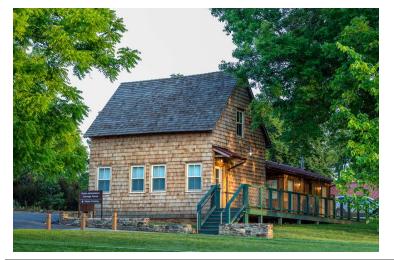
The existing Carriage House had a pest and water-damaged foundation and no windows. The interior was an enclosed garage, used for storage, with a steep narrow stair to a loft above the garage.

The renovated Carriage House has windows and walkways that engage the site. The interior is light-filled and airy. A small addition provides accessible restrooms and other service functions.
