Renovations to Public Spaces of The Crest at Congressional Plaza

Rockville MD Category: Renovation, Non-Residential

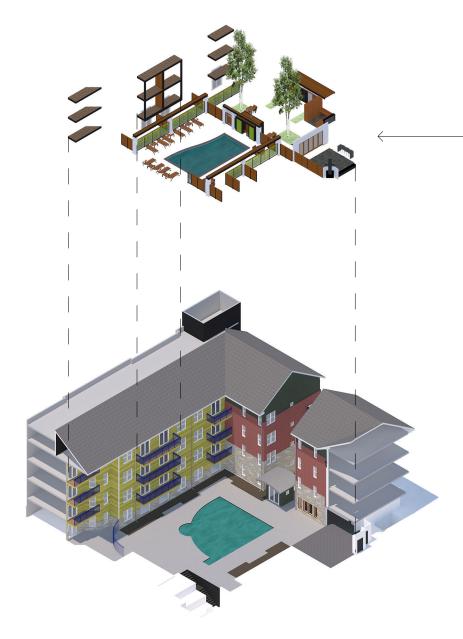
New architectural elements placed to subdivide existing courtyard into multiple private and public spaces

What had been one, big undifferentiated space, devoted entirely to a seasonal use, is now 12 separately defined spaces ranging in function from private to semipublic to public.

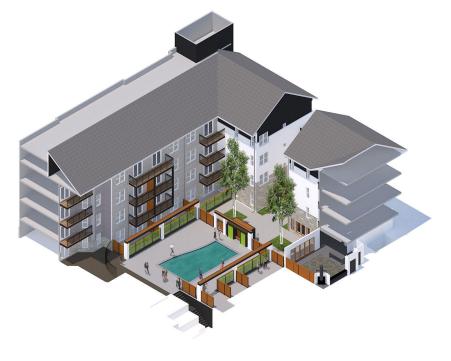
New

Existing

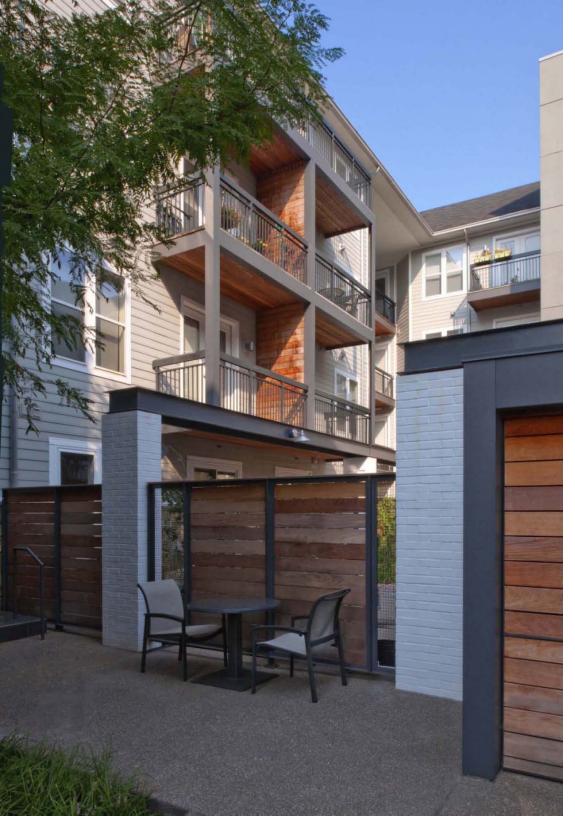
Elements and materials of the garden structures are extended upward on to the facades.

By shrinking the pool and its dedicated fence-enclosed terrace, communal outdoor space could be created off the renovated lobby and private gardens provided for all the ground floor units facing the courtyard. The only modifications to the building itself was a new, more subtle color scheme, and the clustering of balconies into larger-scaled figures to give hierarchy to the courtyard facades, and privacy to adjacent balconies.

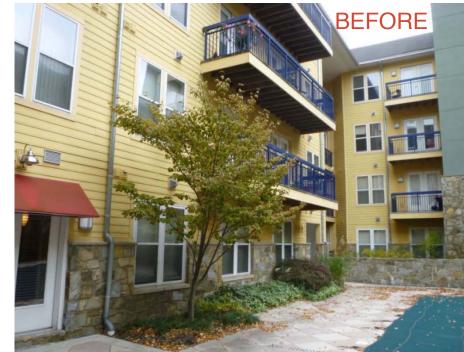
Original closed lounge area is now opened to both the lobby and to a new courtyard, and repurposed as a cafe.

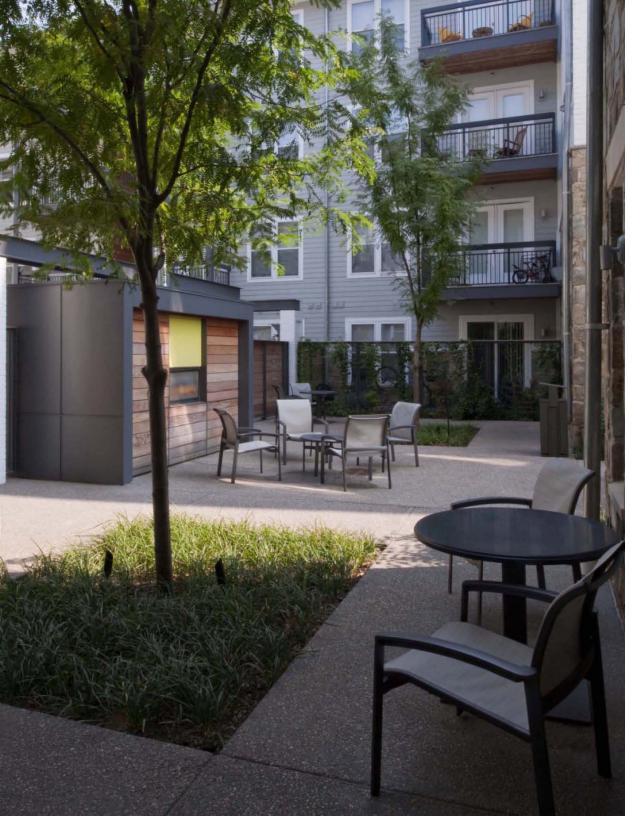
A new outdoor space, accessible even when the pool is closed, opens from the cafe and lobby.

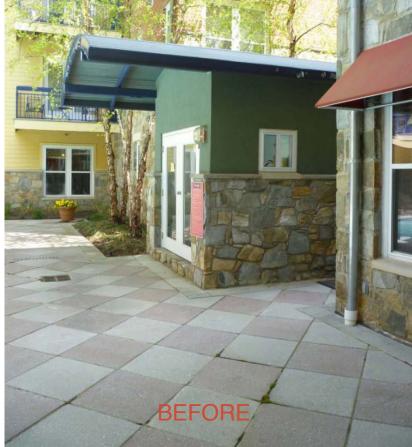
Folding glass walls allow lobby and cafe to fully open to the courtyard.

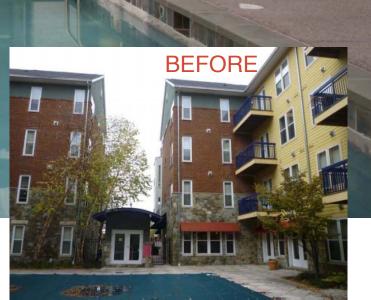
Lifeguard shed has been replaced with a pergola with gates to the adjacent cafe court & a bench on axis with the pool.

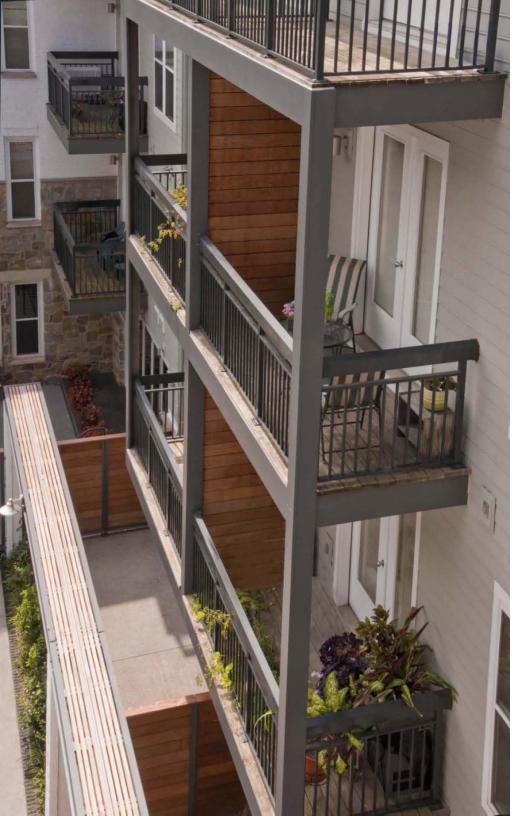
Horizontal balconies with no privacy between adjacent units have been divided and framed to make loggias for each apartment.
