## Hutner Pool & Porch

Chevy Chase, Maryland

Twenty years after we renovated our clients' Chevy Chase rambler, we were asked back to design their retirement present to themselves — a swimming pool and a screened porch.

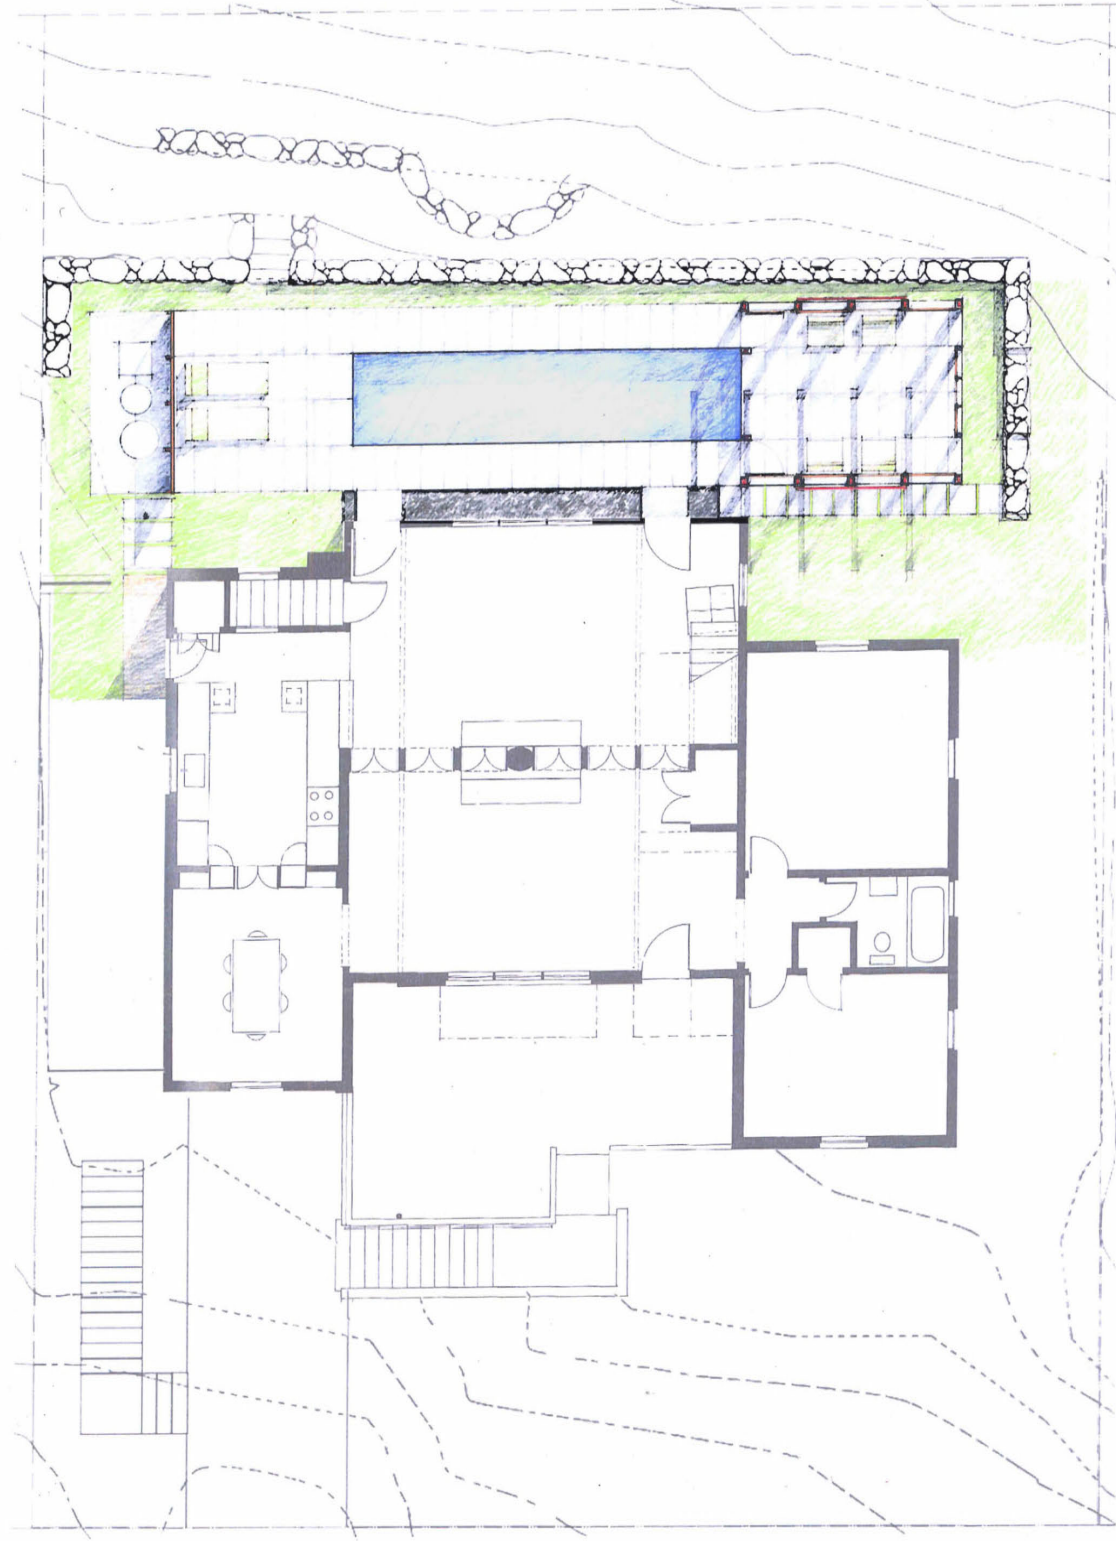
existing house renovated 1995

new  
pool & porch

existing  
hill garden

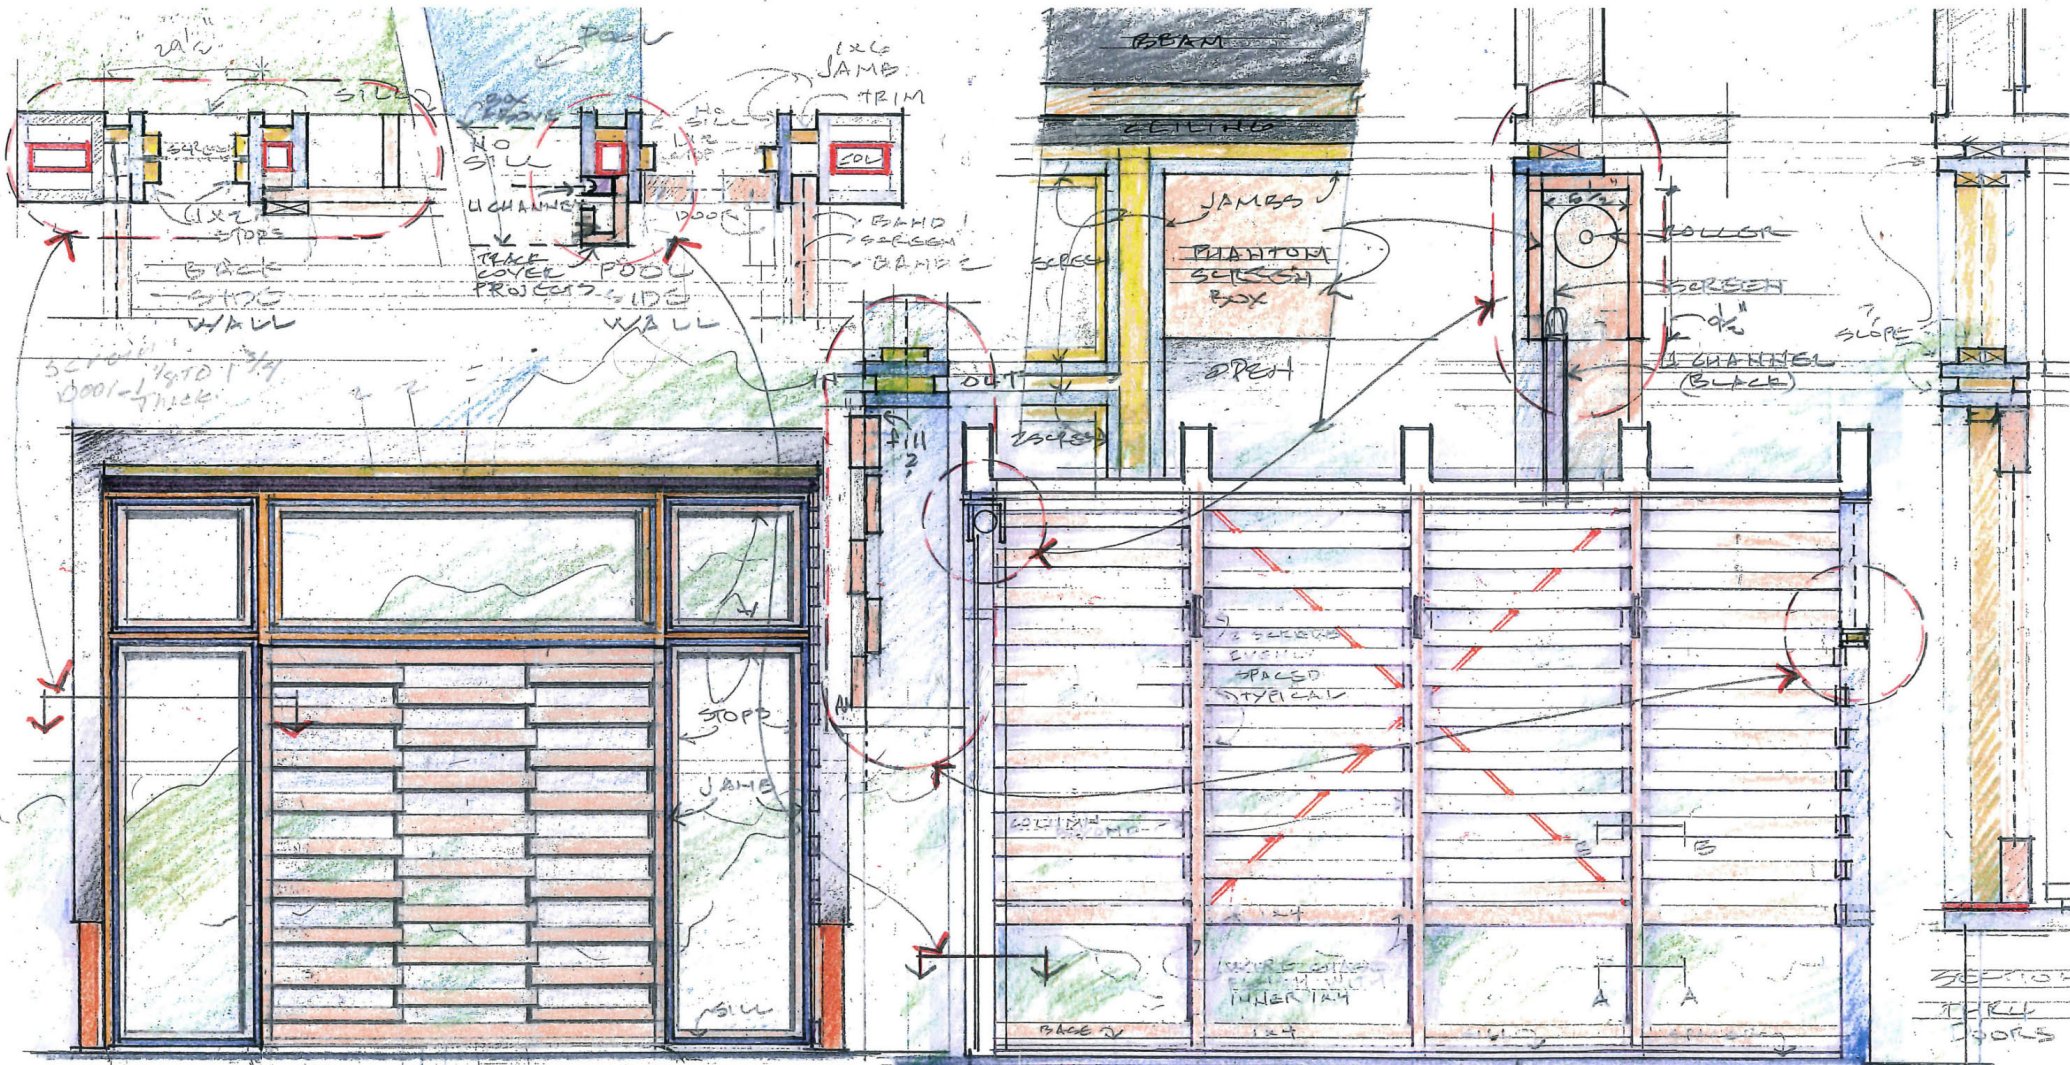
A-A LOWER COLUMN

B-B UPPER COLUMN

The screened porch is an exercise in dappled sun and carpentry. It is supported on steel legs which

continue, partially clad in wood, to the roof, where corresponding beams cross over the top. These are exposed to view and make the roof a fifth facade, visible from the second story master bedroom.
