Name:
BLACK METAL/WHITE PLASTER

Location:
ARLINGTON, VA

Category:
RESIDENTIAL

Editing away subsequent inconsistent trim imposed on a 1920s Tudor reveals the original simple palate of black metal and white plaster, defining the inherent character of the home and informing a breakfast/kitchen addition. Like the existing, the addition's simple, white untrimmed walls are a backdrop for black metal architectural elements such as island shelving and steel I-beams with exposed bolting. Ceiling angles of the existing home are recalled at the addition, both on the interior and outside. Paired dormers overhead offer the reshuffled master bedroom suite views across the addition's two-story chiseled ceiling to trees and sky. An existing den and workspace peripheral to the addition employ a new laundry, back kitchen, and butler's pantry. At the pantry, a surprise concrete floor cavity found during construction lead to the discovery of bomb shelter. The location of the wine room, an original program request is reconsidered and reallocated through the concrete cavity by a stairway to the bunker. Ceiling, walls, and even wall construction are left exposed behind floating metal wine racks recall

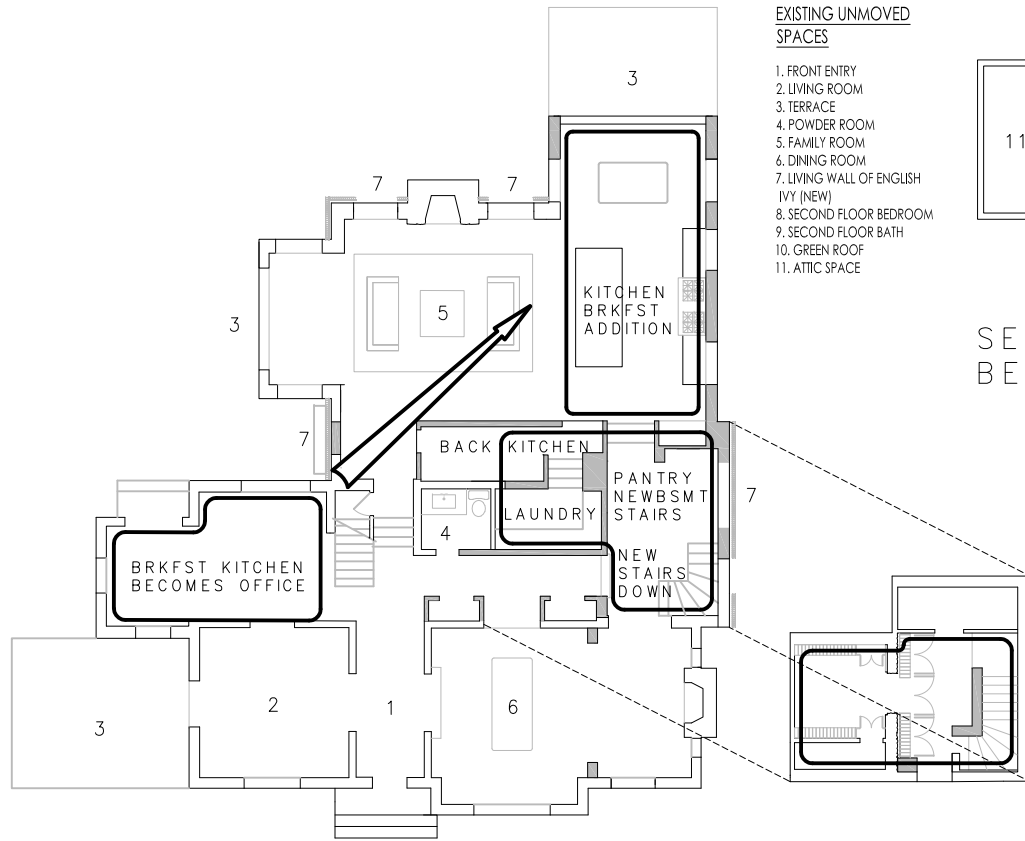
FIRST FLOOR

1. FRONT ENTRY
2. LIVING ROOM
3. TERRACE
4. POWDER ROOM
5. FAMILY ROOM
6. DINING ROOM
7. LIVING WALL OF ENGLISH IVY (NEW)
8. SECOND FLOOR BEDROOM
9. SECOND FLOOR BATH
10. GREEN ROOF
11. ATTIC SPACE

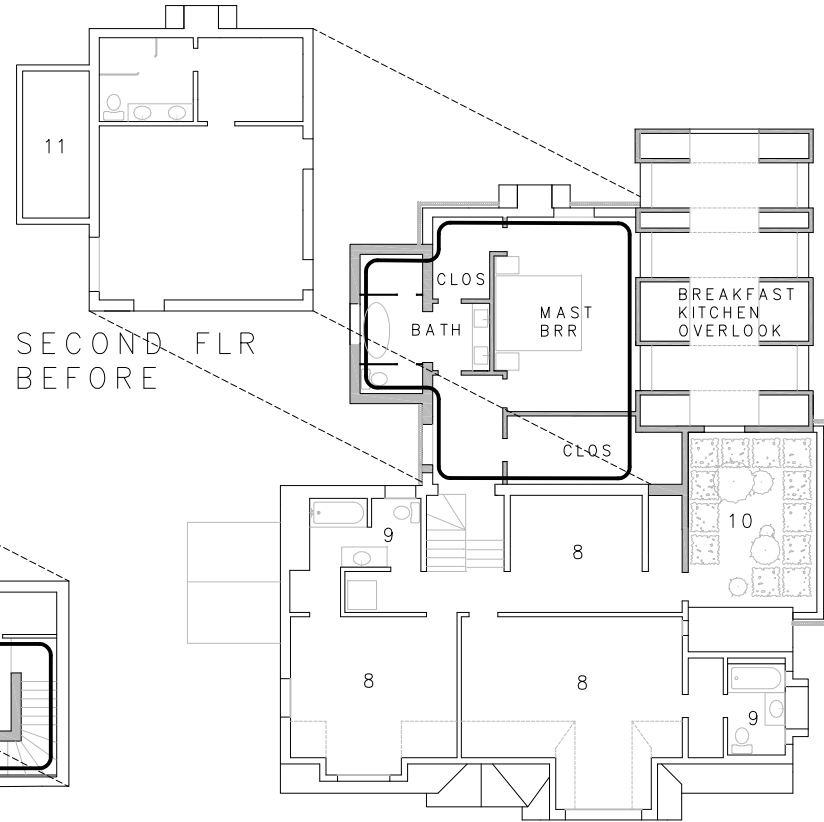
SECOND FLOOR

SECOND FLR BEFORE

PARTIAL BASEMENT
NEW WINE ROOM

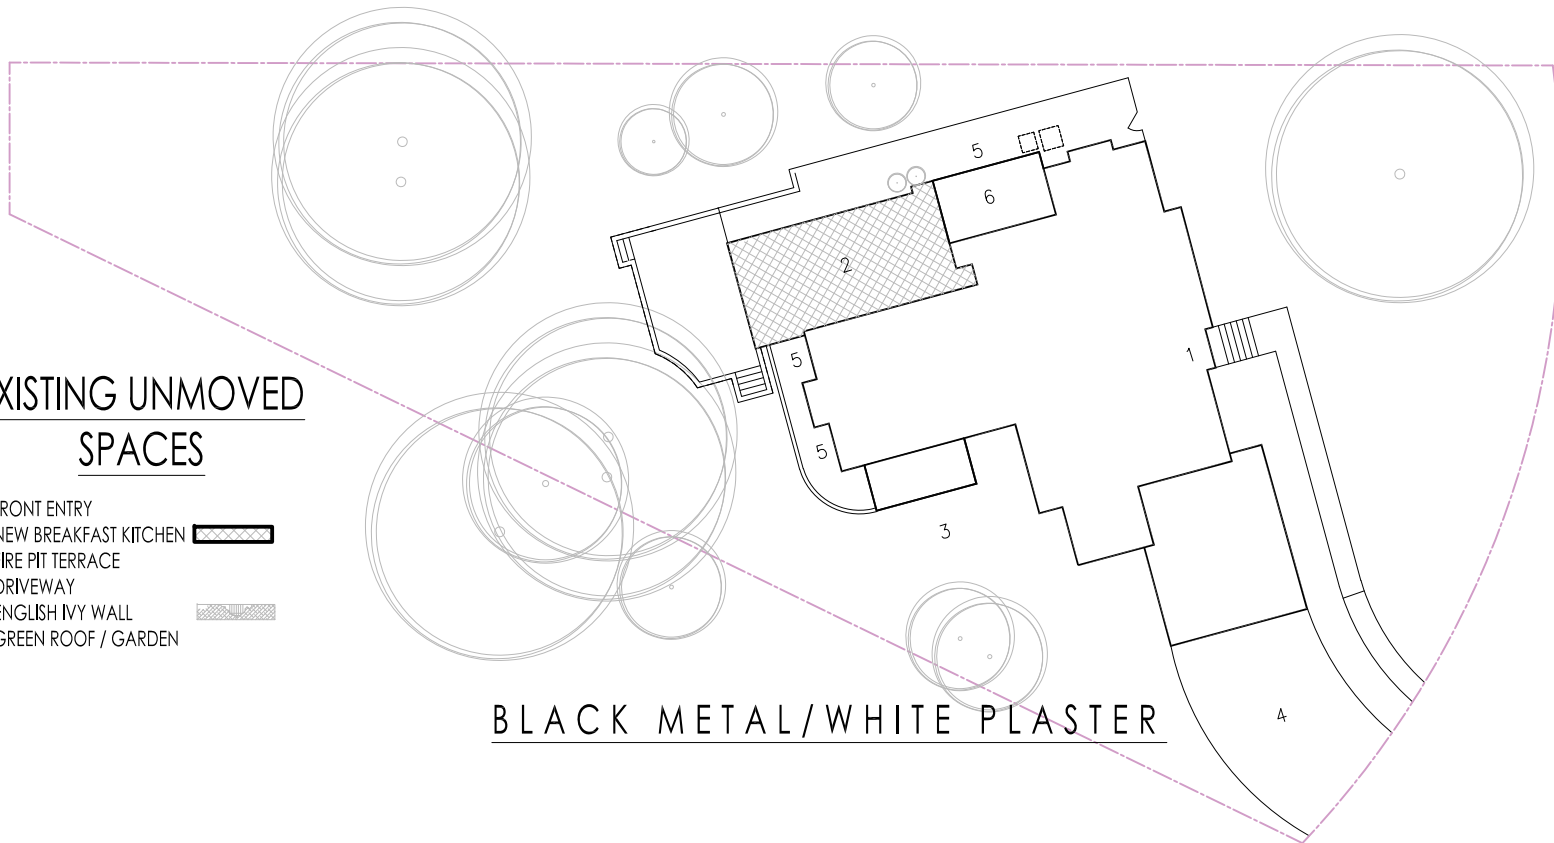
- 1. FRONT ENTRY
- 2. NEW BREAKFAST KITCHEN  
- 3. FIRE PIT TERRACE
- 4. DRIVEWAY
- 5. ENGLISH IVY WALL  
- 6. GREEN ROOF / GARDEN
